HISTORIC STRUCTURES VISUAL IMPACT ASSESSMENT REPORT

SOUTH CAROLINA ELECTRIC & GAS COMPANY
Cayce, South Carolina

Historic Structures Visual Impact Assessment Report
for the
Lyles-Saluda River-Lake Murray 230 kV Lines

November 2013

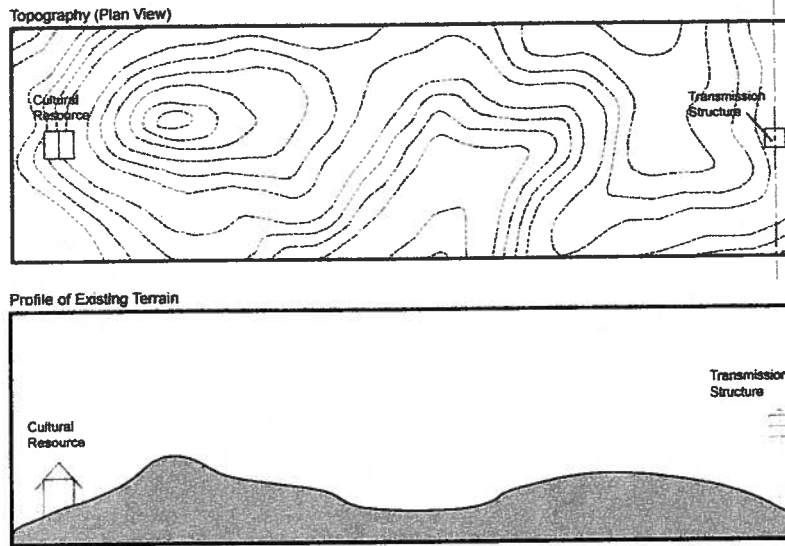
Figure 2: Topography

This report includes literary evaluations, mapping, photography, and line of sight profile graphs to clearly display any significant historic structures or places that may be impacted by a view of the proposed Lyles-Saluda River-Lake Murray 230 kV Line. Figures 2, 3, 4, 5 and 6 are included to graphically illustrate how Pike analyzed view probability from each historic resource by applying factors that included historic resource locations, transmission line structure locations (based on engineering assumptions), topography and vegetation, if any, between the historic resource and 230 kV transmission line structures. Figures 2, 3 and 4 illustrate how view analysis profiles are developed using topography and vegetative conditions present between viewpoints (i.e., specific historic resource locations) and proposed transmission line structures for the purposes of analyzing how views from the historic resources in the direction of the proposed transmission line are affected by the combination of landforms and vegetation. Figures 5 and 6 graphically depict how computer analyses, based on line of sight from the resources to proposed transmission line structures, are completed using the information developed from analyzing the topography and vegetative cover present between the resource and proposed transmission line structures.

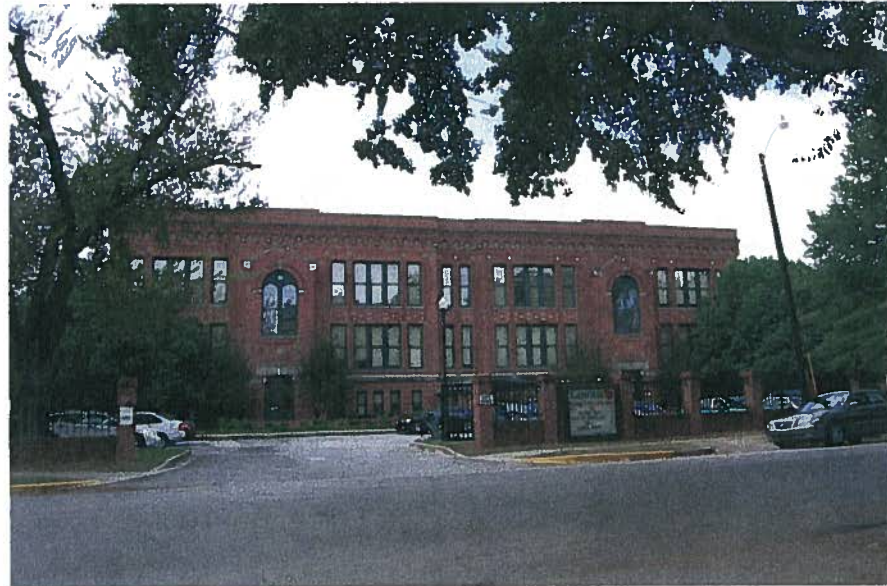
Historic Site: Logan School

Field Visit & Analysis: Due to heavy mid-ground screening and distance the proposed line route will not be visible.

Conclusion Based on the Visual Impact Assessment and Field Visit: No view

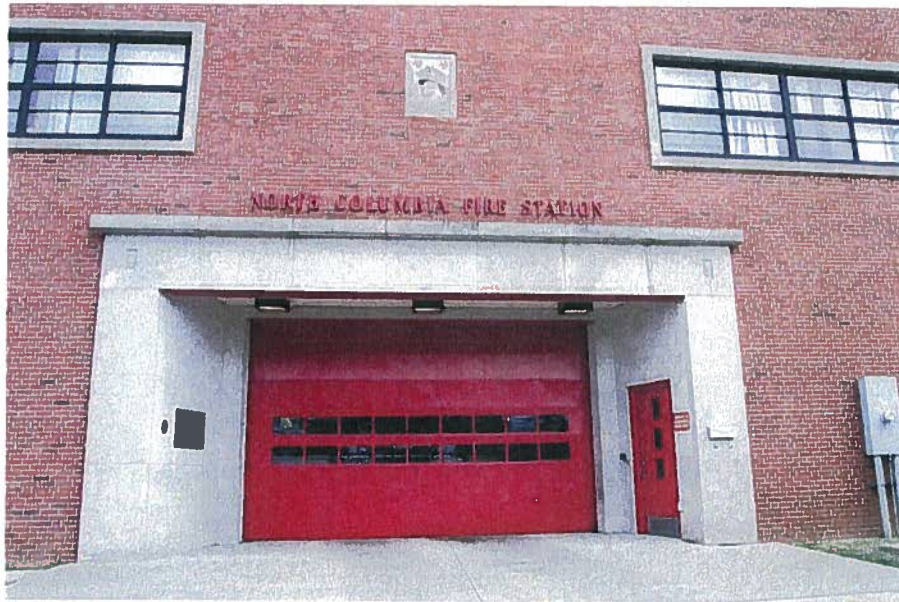
Historic Site: North Columbia Fire Station No. 7

Field Visit & Analysis: Due to heavy mid-ground screening and distance the proposed line route will not be visible.

Conclusion Based on the Visual Impact Assessment and Field Visit: No view

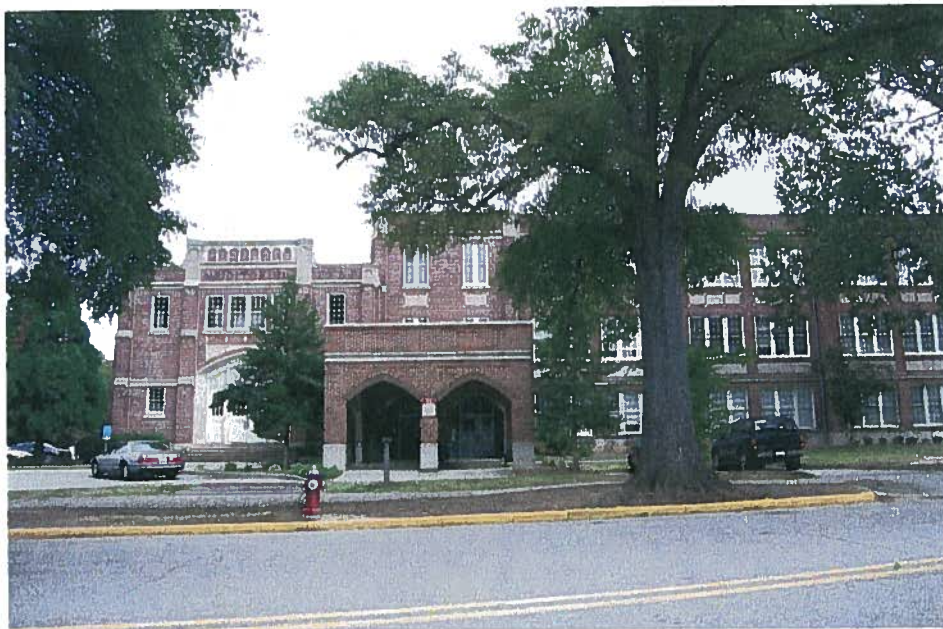
Historic Site: Wardlaw Junior High School

Field Visit & Analysis: Due to heavy mid-ground screening and distance the proposed line route will not be visible.

Conclusion Based on the Visual Impact Assessment and Field Visit: No view

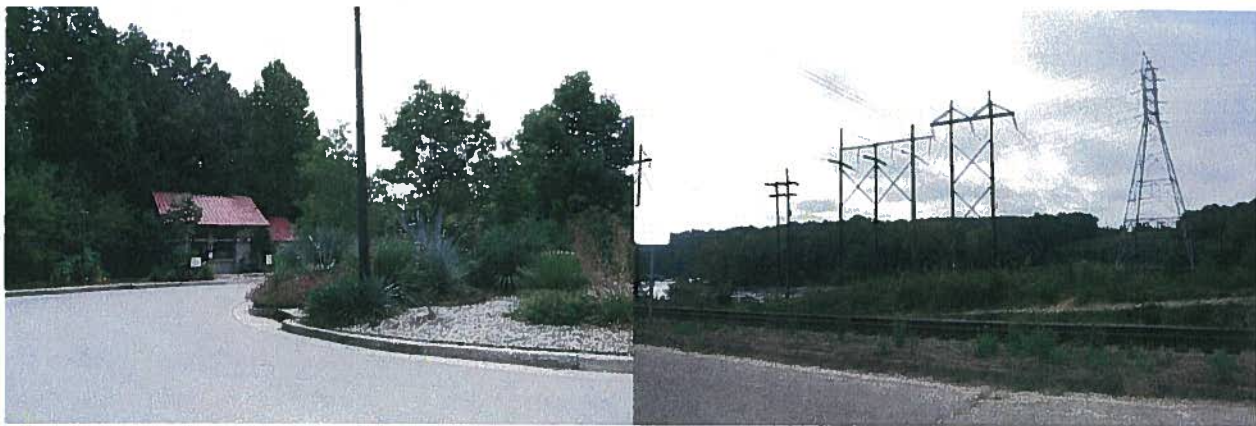
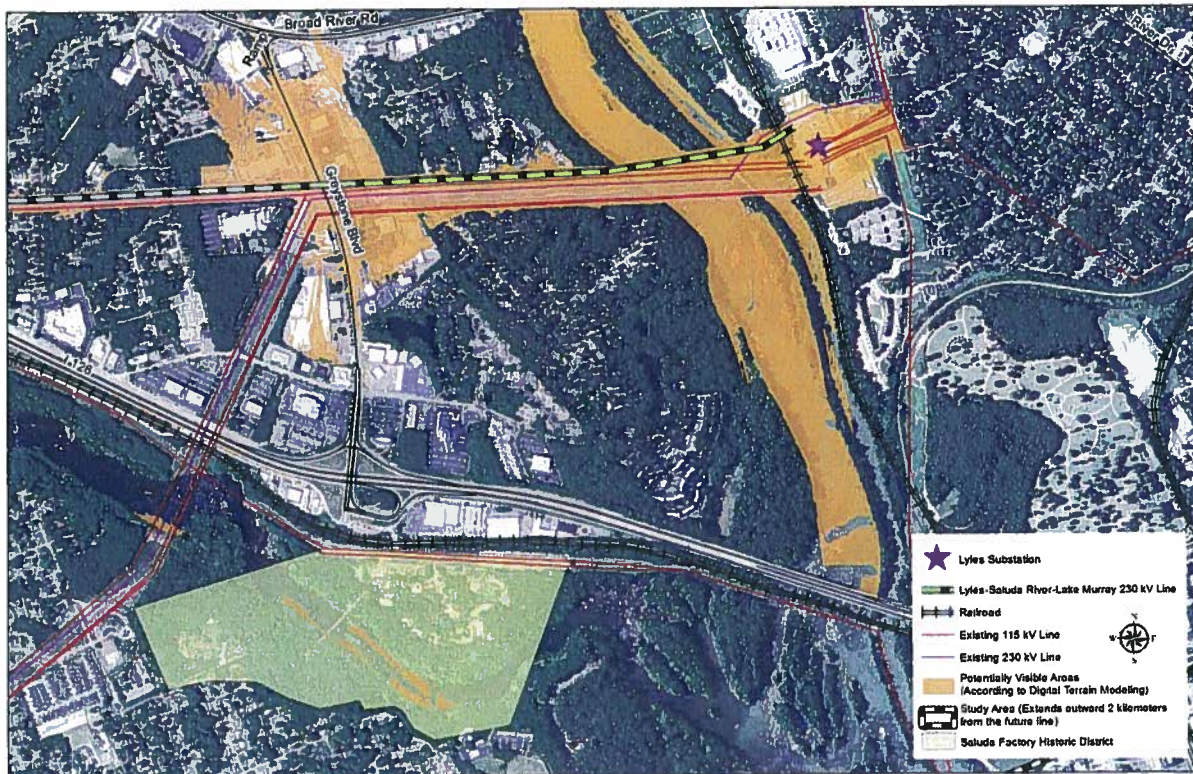
Historic Site: Saluda Factory Historic District

Field Visit & Analysis: The Saluda Factory Historic District is located in an area of low elevation on both banks of the Saluda River with limited views out due to heavy forest cover. Digital viewshed modeling showed that portions of the district within the waters of the Saluda River will have potential views of the line route. However, the views in the direction of the line route are over 1.6 miles away and are highly modified by existing high voltage transmission that run along its western and northern boundaries. Views of the line route, if any, will be negligible due to the high degree of foreground and mid-ground screening, elevation change, and distance.

Conclusion Based on the Visual Impact Assessment and Field Visit: Views, if any, will not be evident to casual viewers.

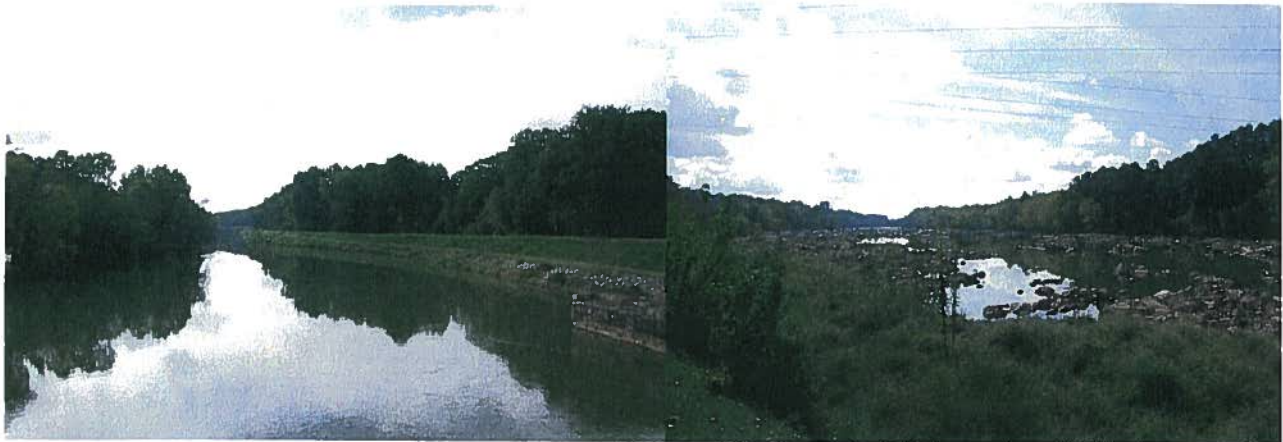
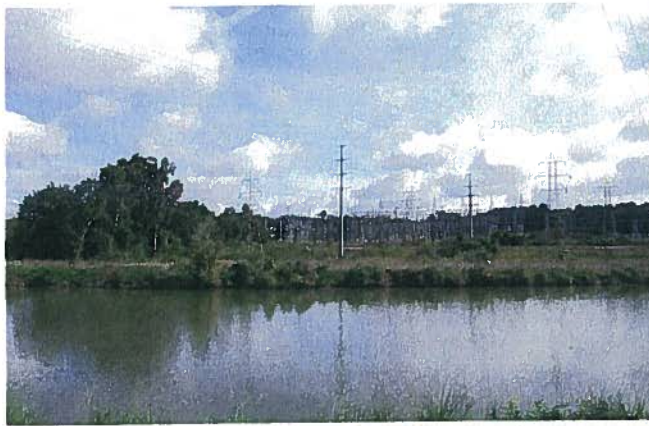
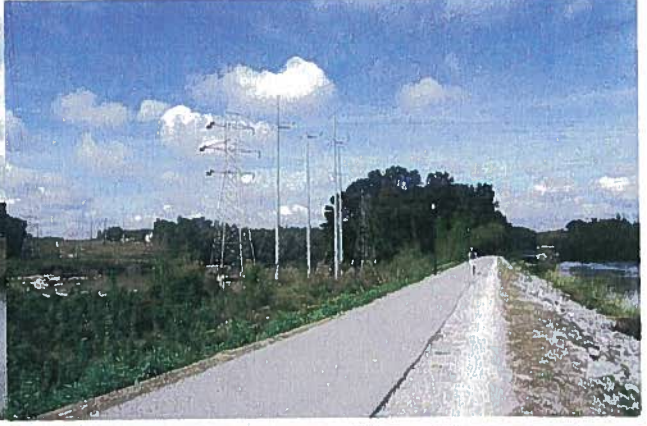
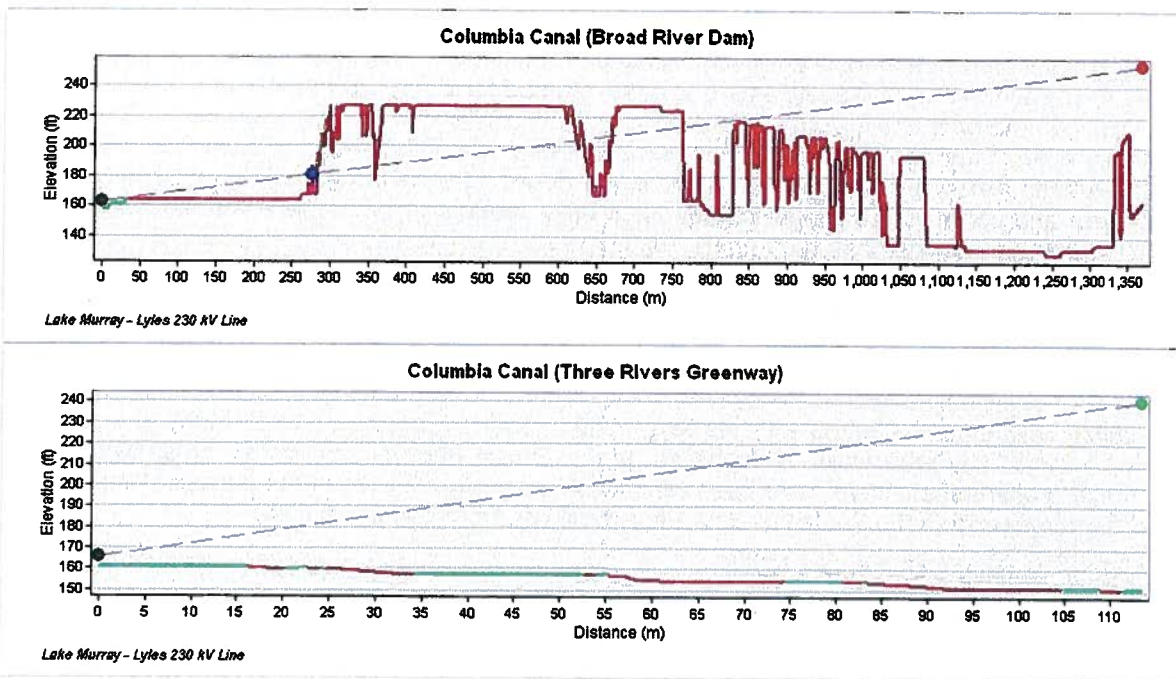
Historic Site: Columbia Canal

Field Visit & Analysis: First created to provide efficient means of transportation and hydroelectric power for the cities of Columbia, West Columbia, and Cayce, the Columbia Canal has recently provided a framework for establishing scenic outdoor recreation areas. Recreation on the Columbia Canal includes running and biking on the Three Rivers Greenway, as well as fishing and kayaking on the two parallel rivers. This resource provides a sense of visual relief from the contrasting urban landscape of the adjacent cities. While the Columbia Canal has largely been transformed into a public park, the historical integrity lies with the industrial character of electric producing facilities, which are inherently associated with high voltage transmission infrastructure. The proposed line route will be utilizing existing right-of-way occupied by a number of transmission lines. Digital viewshed modeling shows that large portions of the district will have potential views of the line route, most of which are from the waters themselves. Potential views from the waters, if any, should not be discounted due its use for recreation.

Conclusion Based on the Visual Impact Assessment and Field Visit: The line will be visible from an approximate 1,500' linear segment of the resource, primarily viewable from the Three Rivers Greenway in the vicinity of the existing 300' wide right-of-way where multiple existing transmission lines cross the Columbia Canal and Broad River. Due to the replacement of an existing double-circuit 115 kV line with a new double circuit 230 kV line on single-steel poles, no change in the visual quality or historic integrity of the Columbia Canal is expected.

Resource	NRHP Classification*	Predicted Visual Effect of the Lyles-Saluda River-Lake Murray 230 kV Line
Columbia Canal	Listed on the NRHP	No net change in visual quality of the resource due to the replacement of an existing line with the new line
Elmwood Cemetery	Listed on the NRHP	Minor view of future line that will not likely be recognized by casual viewers
Saluda Factory Historic District	Listed on the NRHP	Views of the future line will be very slight and not likely recognized by casual viewers due to foreground/mid-ground screening and distance
City Cemetery / Public Cemetery / Potters field	Eligible for Listing on the NRHP	Views of the future line will be extremely slight and not likely recognized by casual viewers due to foreground/mid-ground screening and distance
Saluda Dam and Powerhouse	Potentially Eligible for Listing on the NRHP	Existing views in the area of the resource are highly modified by power generation and transmission facilities. The addition of the line, though it will be openly visible, will not measurably affect current views.

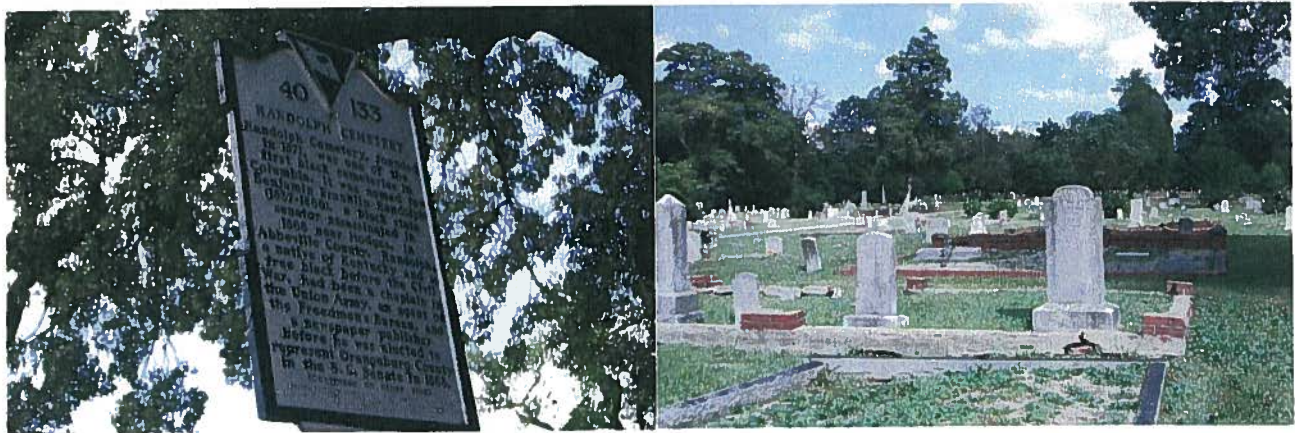
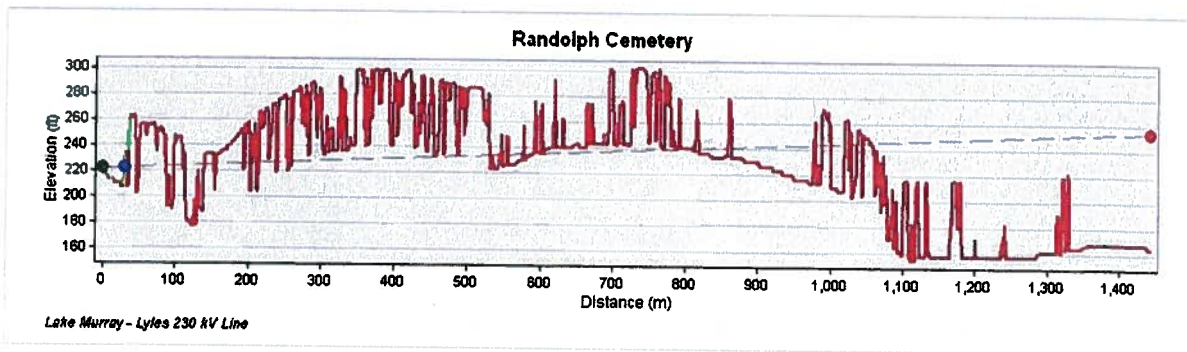
Historic Site: Randolph Cemetery

Field Visit & Analysis: Due to heavy mid-ground screening, distance, and topography the proposed line route will not be visible.

Conclusion Based on the Visual Impact Assessment and Field Visit: No view

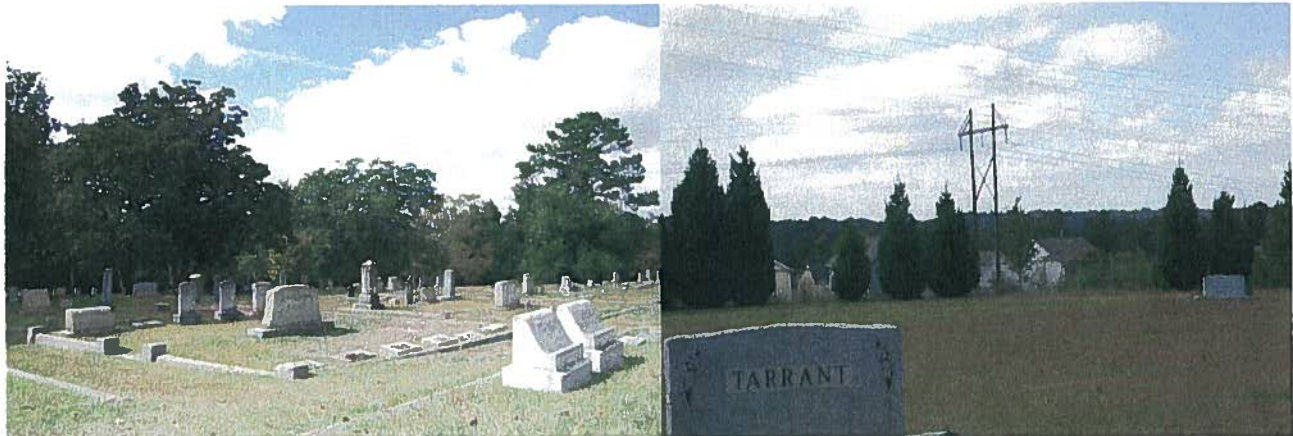
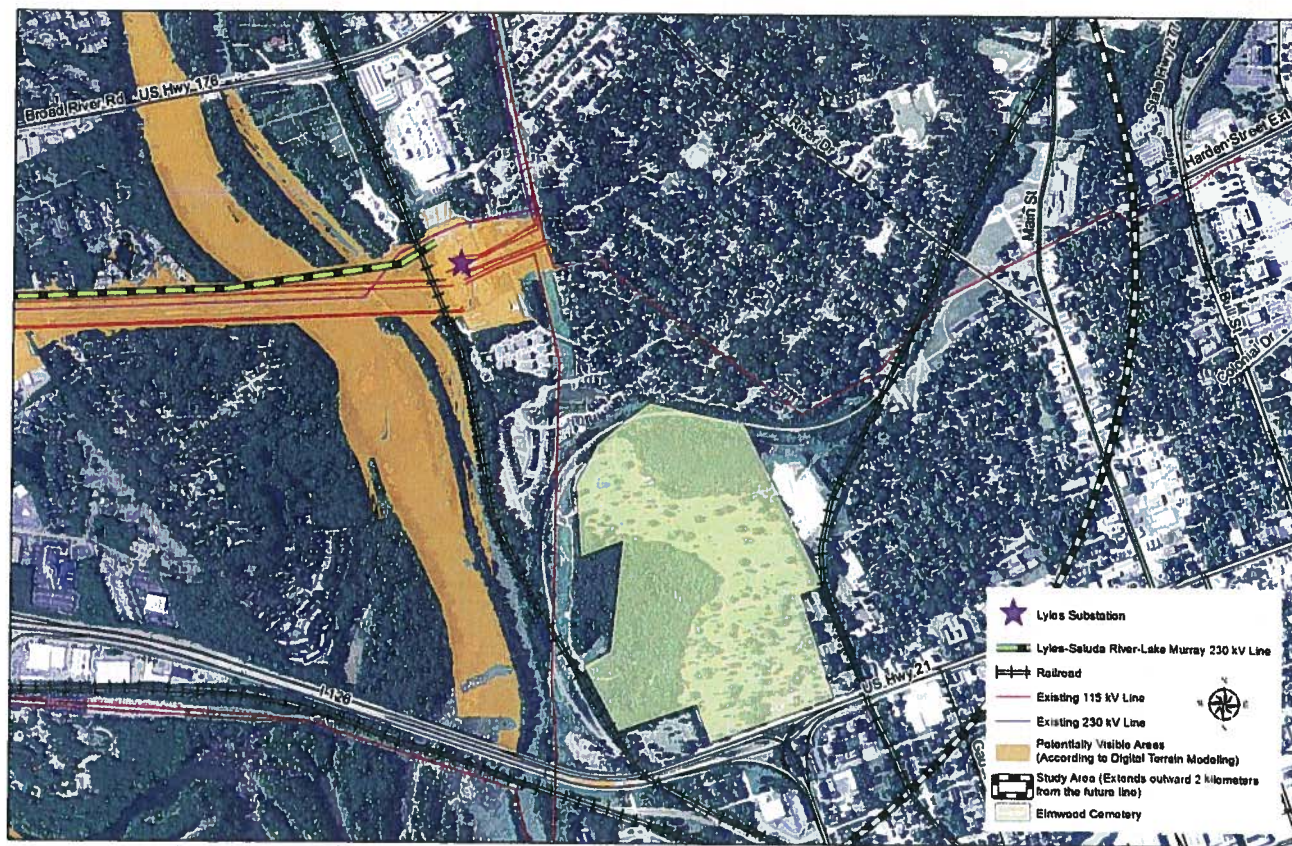
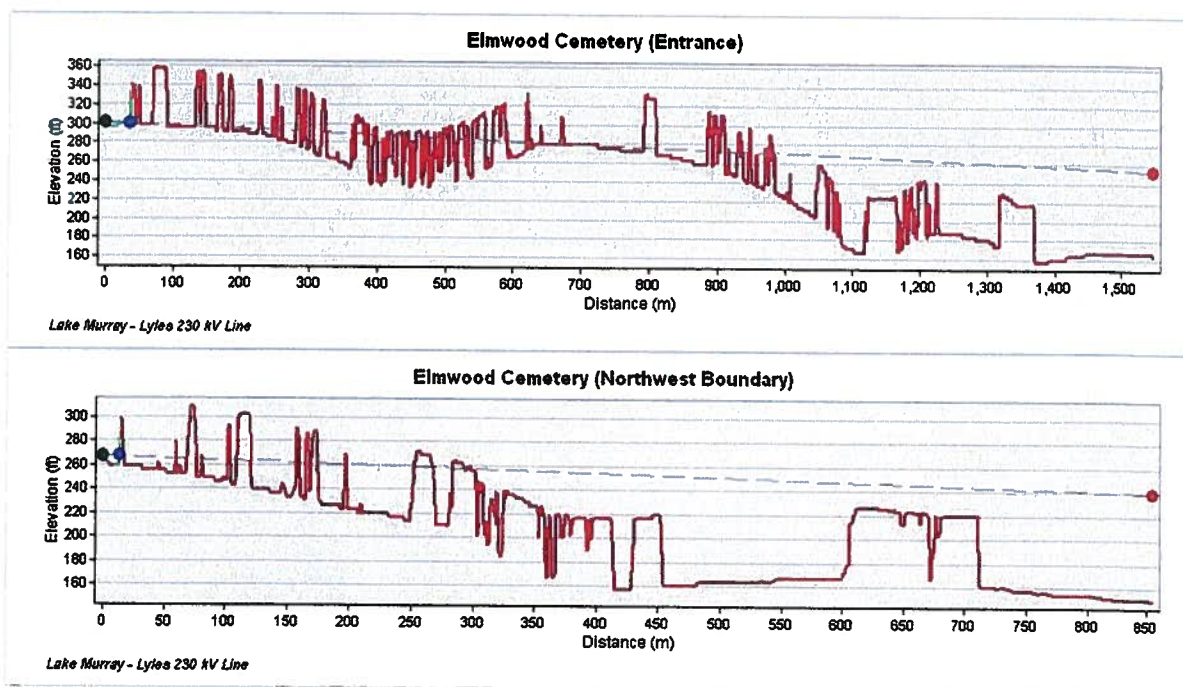
Historic Site: Elmwood Cemetery

Field Visit & Analysis: Contrary to the digital view model, which displays all visual obstructions as generic and opaque forms, the existing transmission structures could be seen from the northwest boundary of the cemetery through an existing transmission structure in the foreground and across a residential neighborhood in the mid-ground. However, the line route is so inferior to the surrounding landscape that it will only be seen by a viewer informed of its precise location.

Conclusion Based on the Visual Impact Assessment and Field Visit: Line route will not be visible to casual viewers.

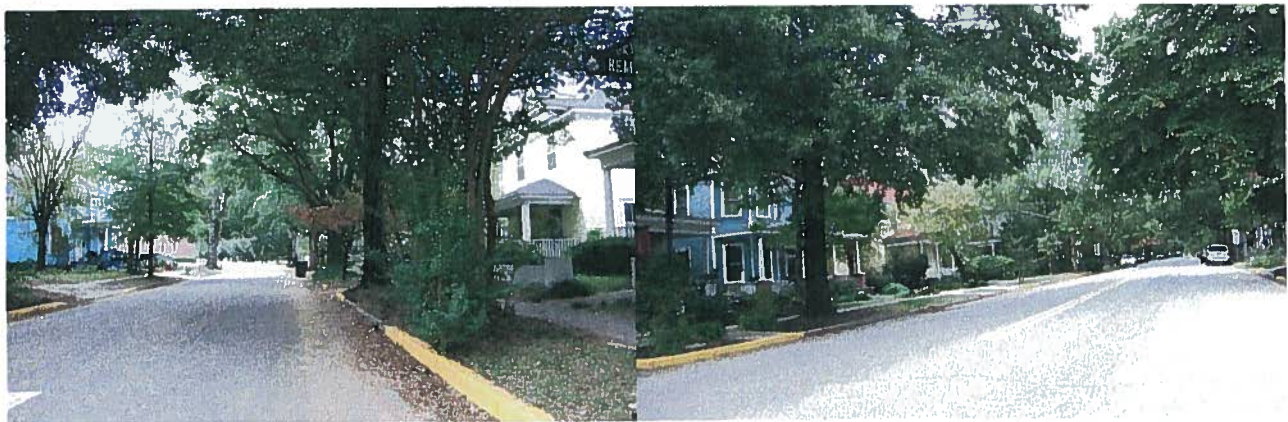
Field Visit & Analysis: Heavy foreground screening; line route will not be visible.

Conclusion Based on the Visual Impact Assessment and Field Visit: No view

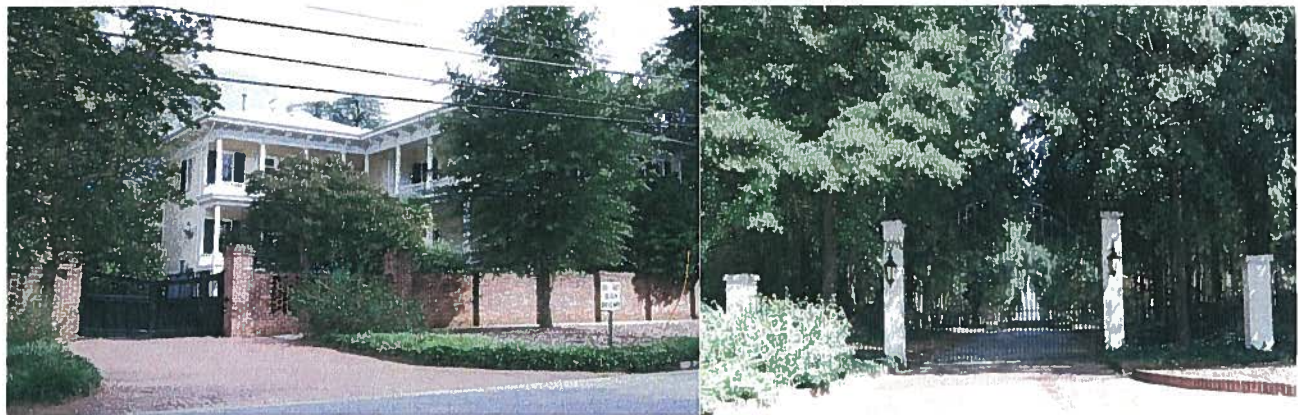
Historic Site: Columbia Historic District I

Field Visit & Analysis: Heavy foreground screening; line route will not be visible.

Conclusion Based on the Visual Impact Assessment and Field Visit: No view

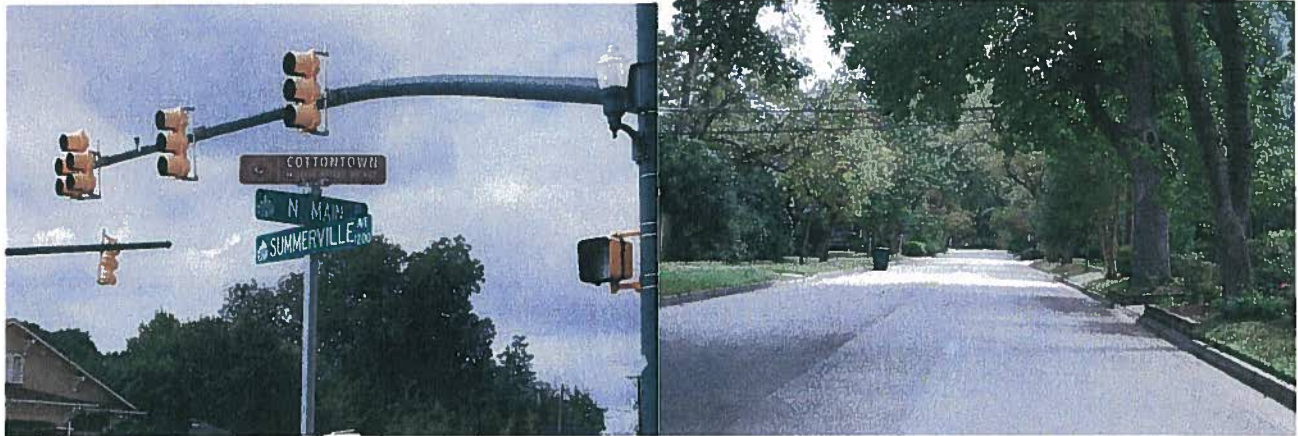
Historic Site: Bellevue Historic District

Field Visit & Analysis: Heavy foreground screening and dramatic elevation change; line route will not be visible.

Conclusion Based on the Visual Impact Assessment and Field Visit: No view

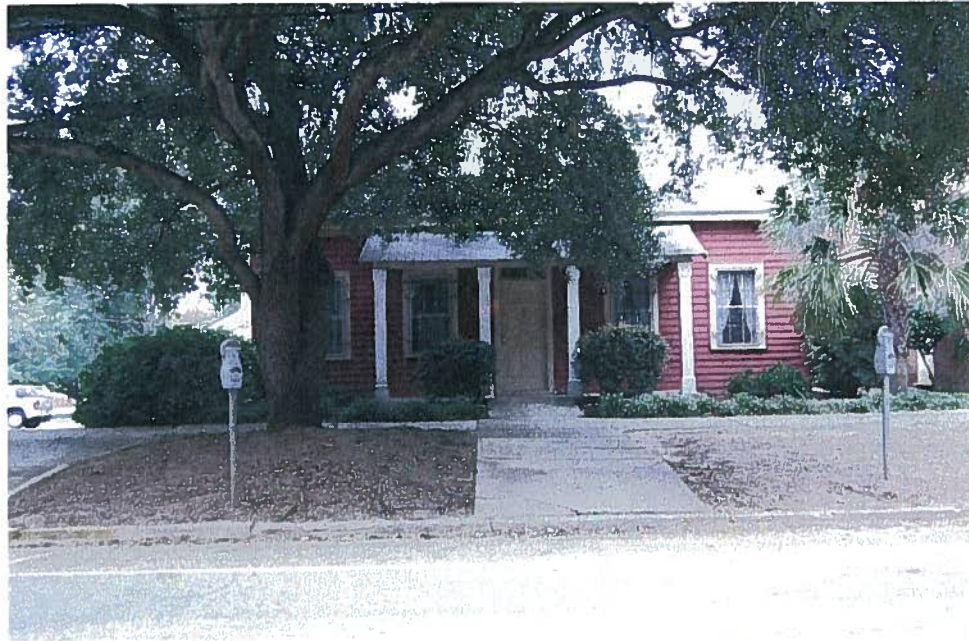
Historic Site: Resource E 1

Field Visit & Analysis: Heavy foreground screening, long distance, and dramatic elevation change; line route will not be visible.

Conclusion Based on the Visual Impact Assessment and Field Visit: No view

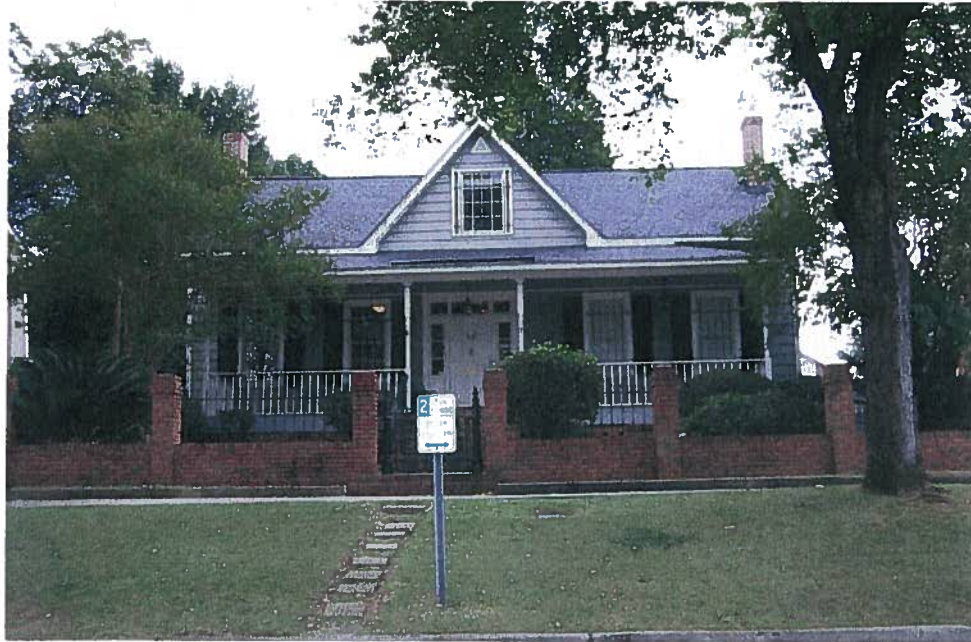
Historic Site: Resource E 2

Field Visit & Analysis: Heavy mid-ground screening, long distance, and dramatic elevation change; line route will not be visible.

Conclusion Based on the Visual Impact Assessment and Field Visit: No view

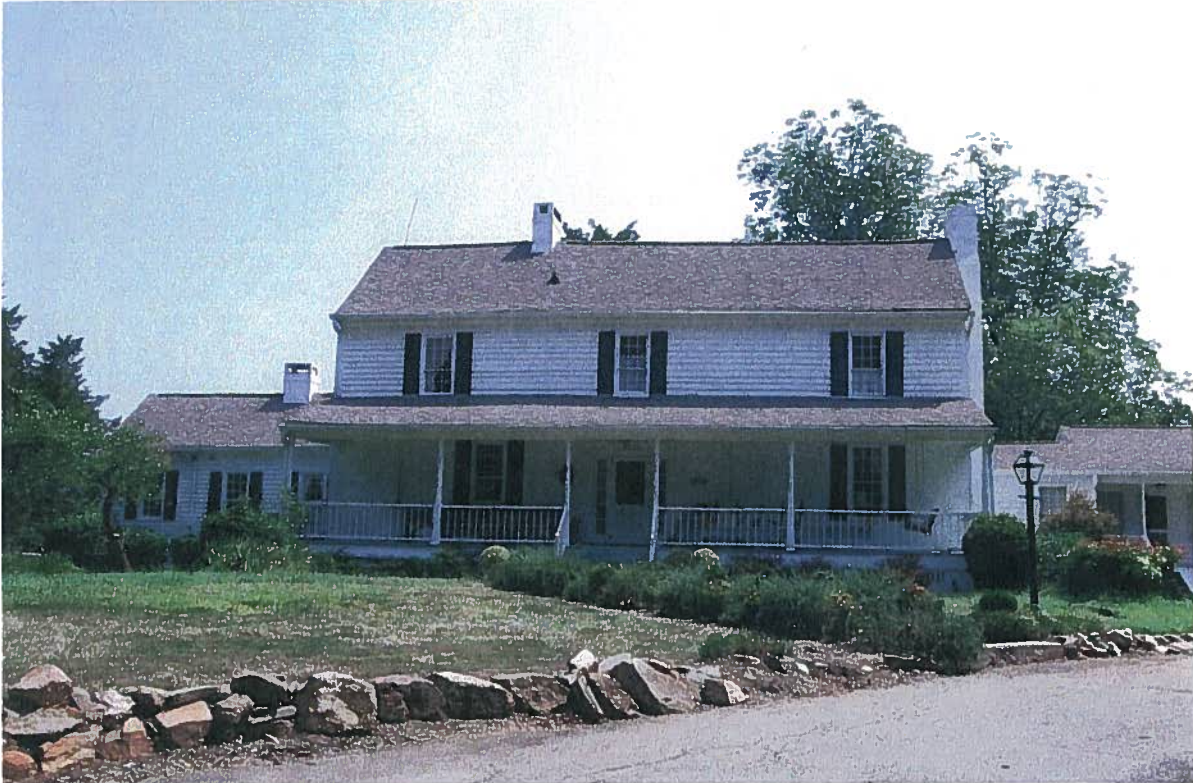
Historic Site: Selwood (243-0126)

Field Visit & Analysis: Heavy mid-ground screening; line route will not be visible.

Conclusion Based on the Visual Impact Assessment and Field Visit: No view

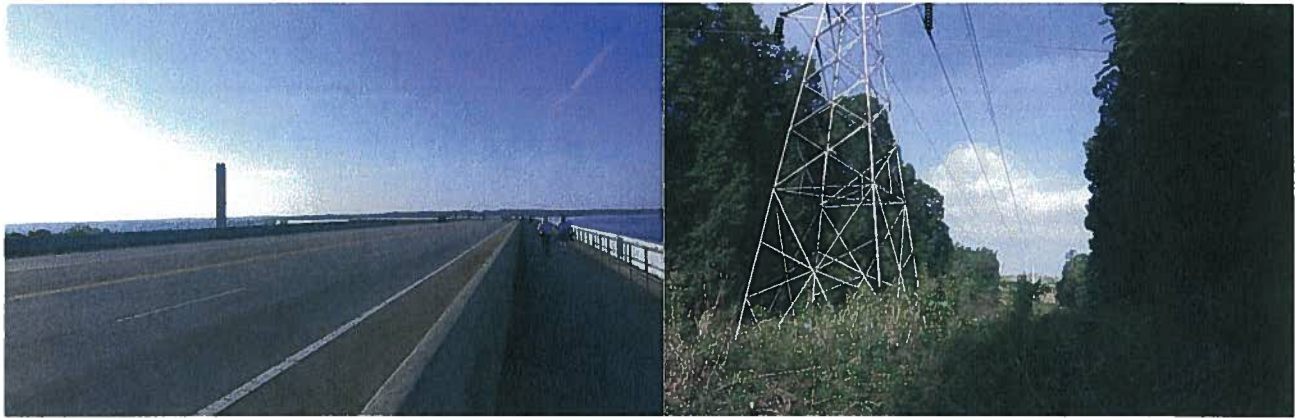
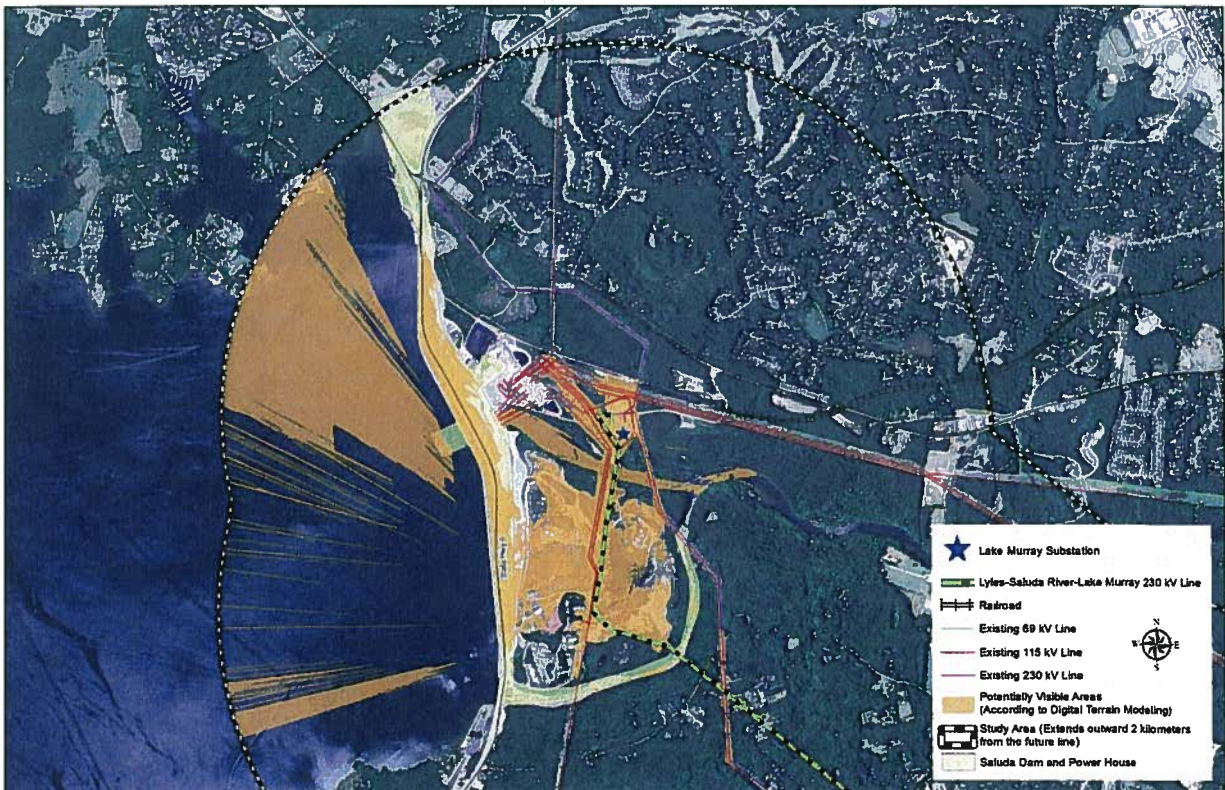
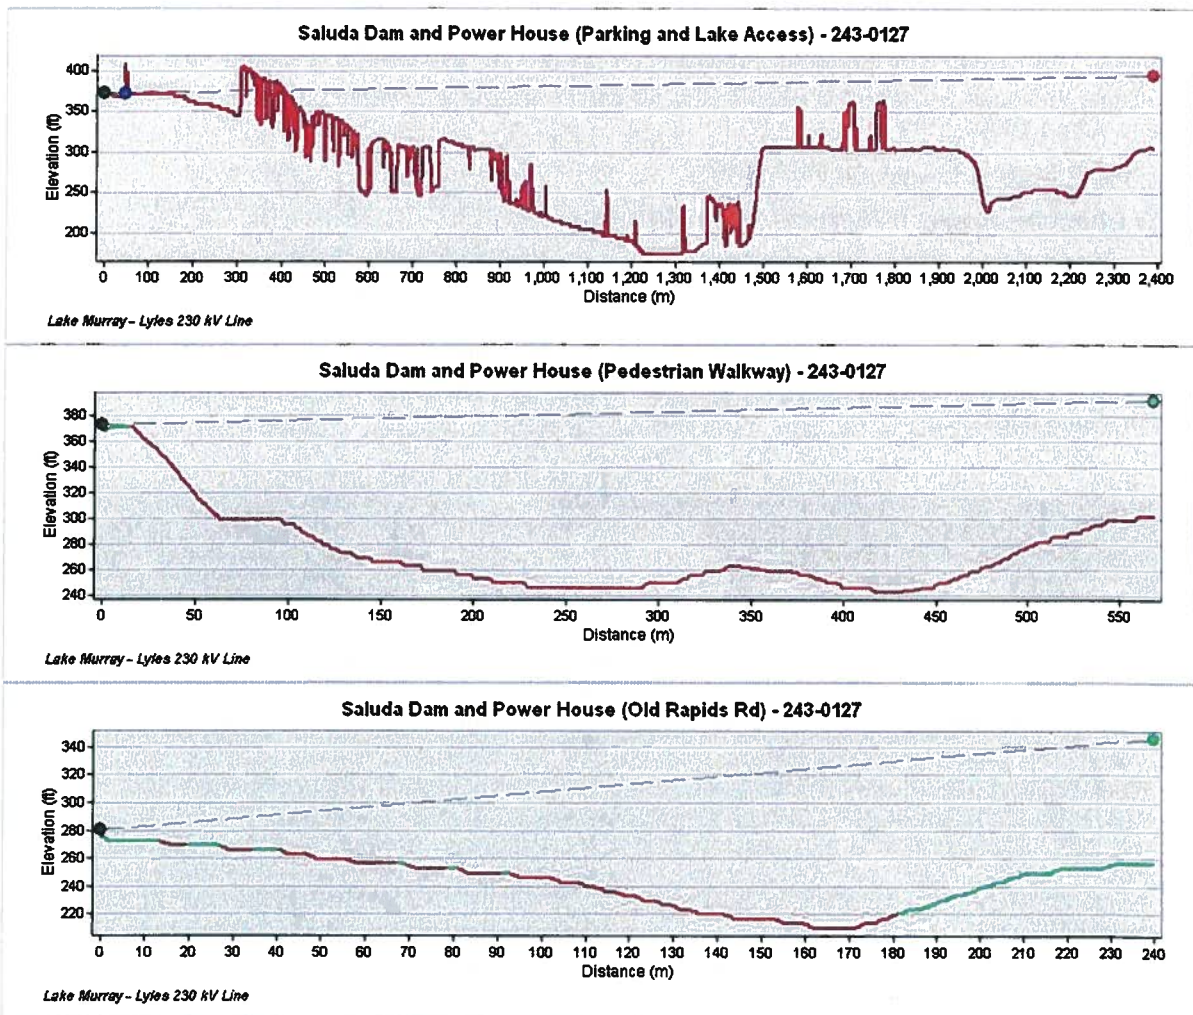
Historic Site: Saluda Dam and Power House (243-0127)

Field Visit & Analysis: The resource is composed of three distinct areas: the parking and lake access area to the north of the dam, the pedestrian walkway across the dam adjacent to SC Highway 6, and the spillway. The line route is situated on the northeast side and at a lower elevation than the dam; therefore, the view of the line route from the parking and lake access area will be blocked by the height of the dam itself. The pedestrian walkway across the dam is used by visitors on a daily basis. While the line route will be visible, it is anticipated that views will be subordinate to those of the lake and dam. The spillway, located off Old Rapids Road, will have an open view as the line crosses the resource. However, the spillway is not accessible to the public and no negative visual impacted is expected.

Conclusion Based on the Visual Impact Assessment and Field Visit: Negligible visual impact will result from construction of the future line due to extensive, existing visual modifications resulting from electrical transmission and generation facilities. Any views of the line will be subordinate to those of the lake and dam.

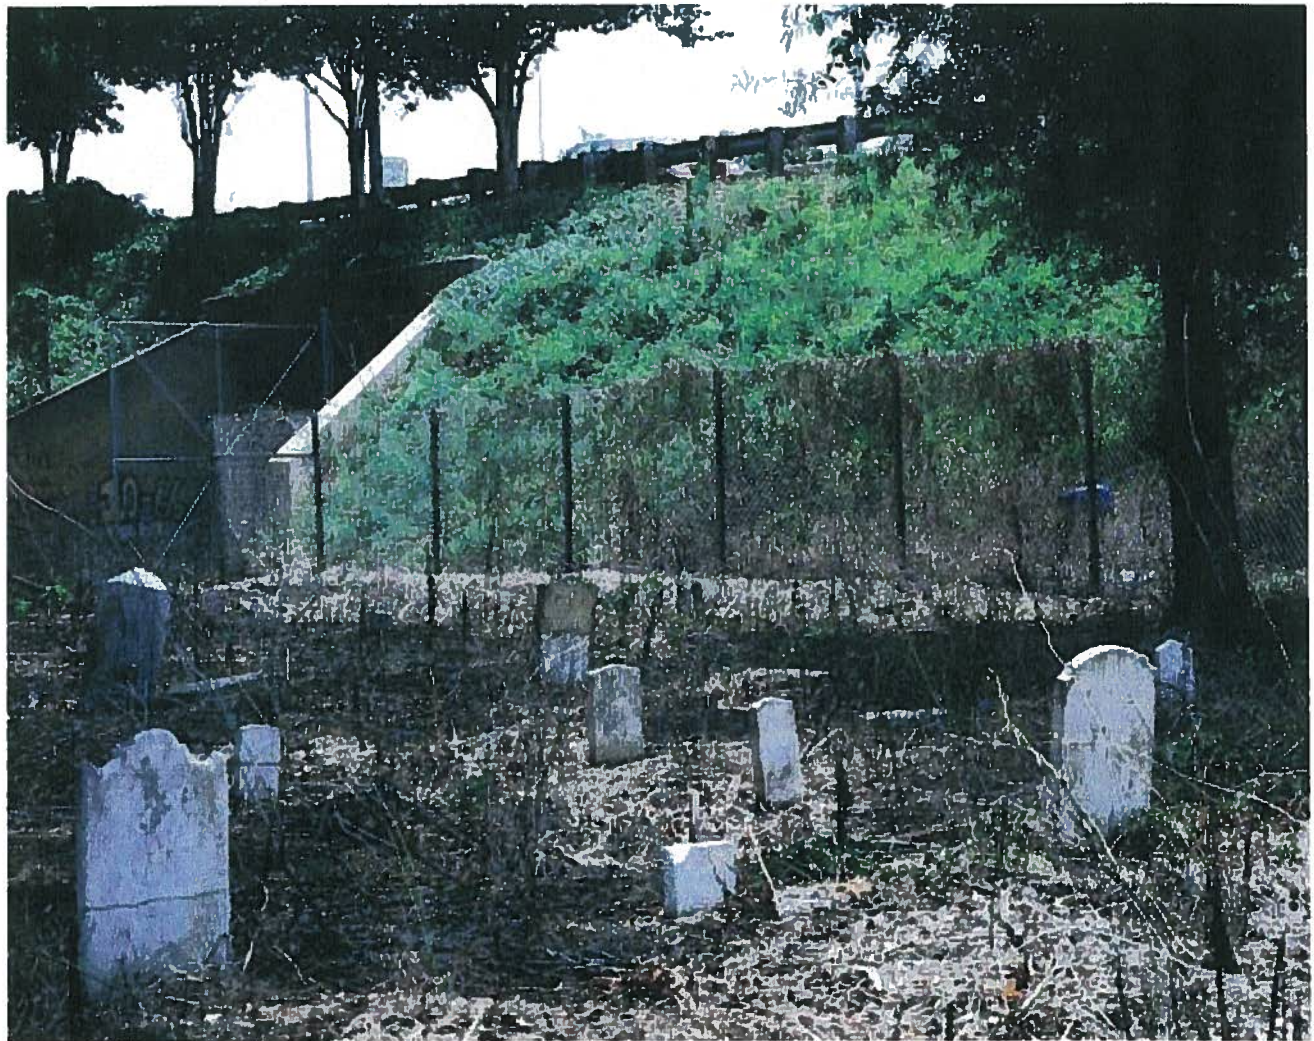
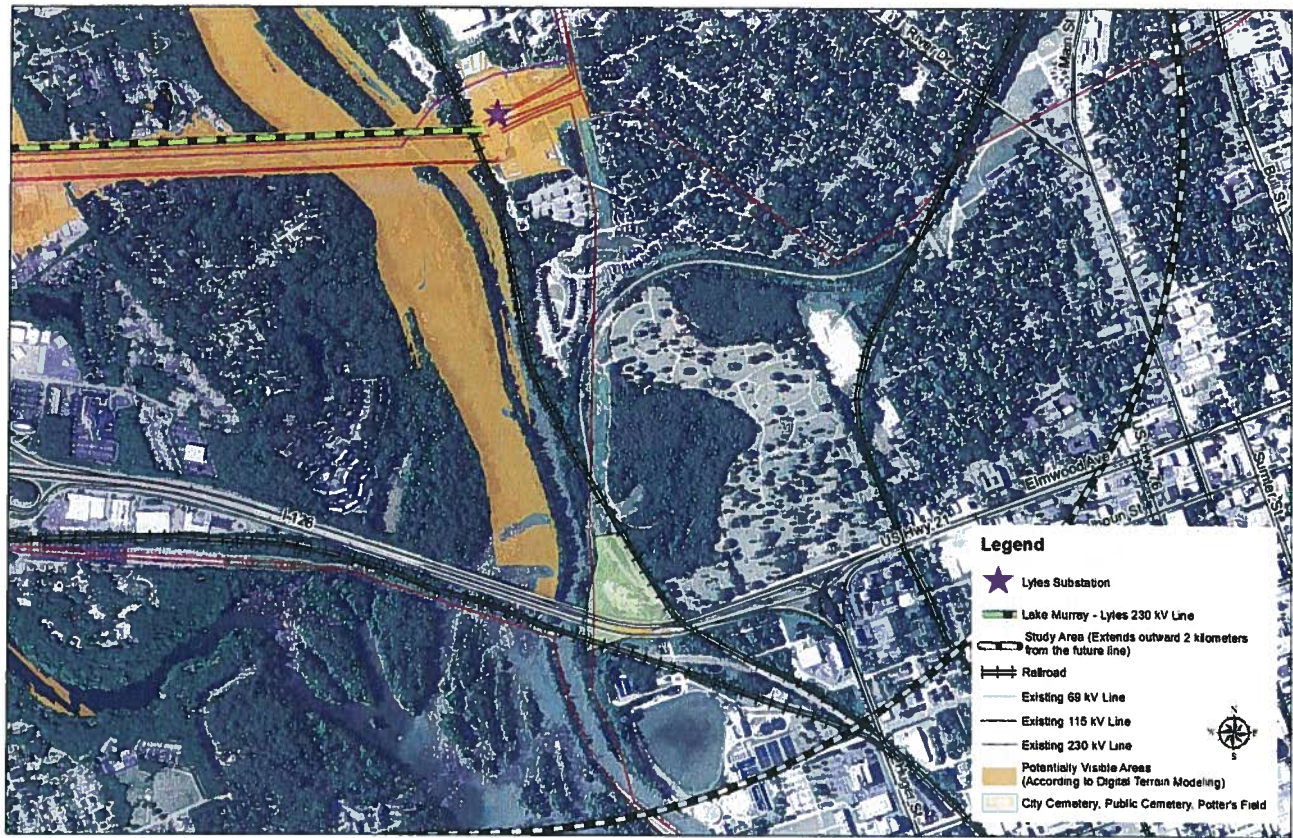
Historic Site: City Cemetery, Public Cemetery, Potter's Field

Field Visit & Analysis: Vehicular access was restricted at the time of the field visit. However, views from Interstate-126 towards the line route were restricted by existing vegetation. Furthermore, existing high-voltage transmission currently run through the site. Digital viewshed modeling showed areas on Interstate-126 within the historic district as having a potential view of the line route. However, further analysis showed that the area of line potentially visible from the resource was over 3 miles away, confirming conclusions made in the field of no view or visual effect.

Conclusion Based on the Visual Impact Assessment and Field Visit: Views, if any, will not be evident to casual viewers.

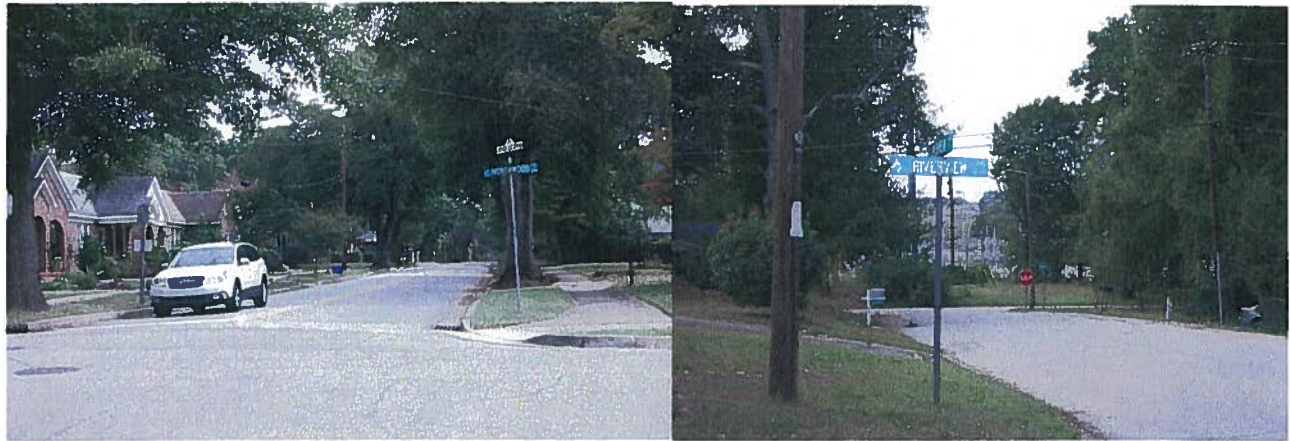
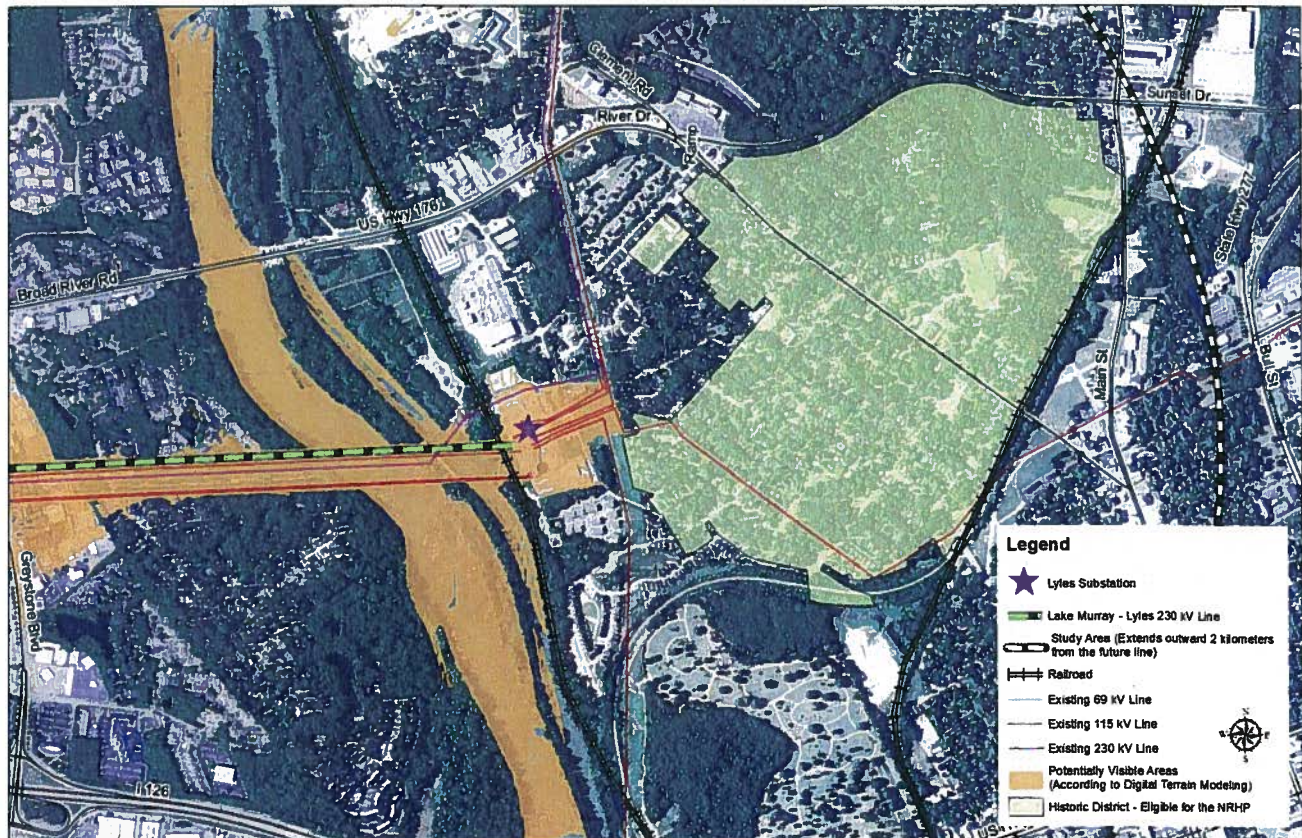
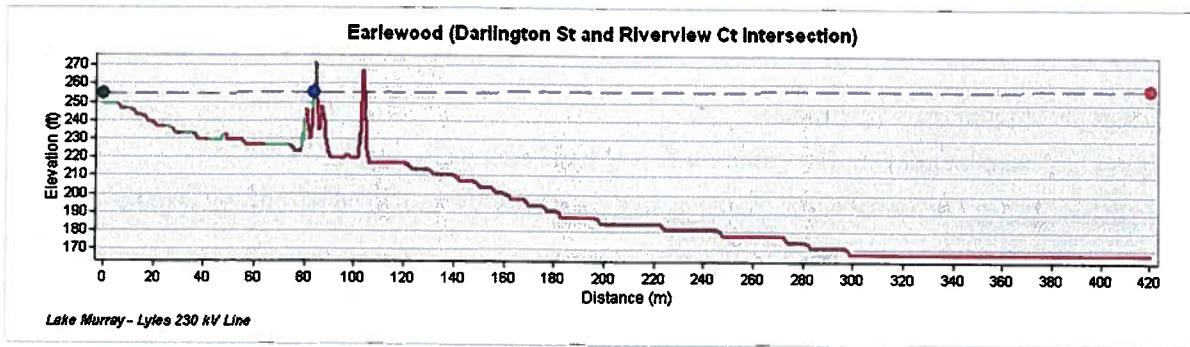
Historic Site: Earlewood

Field Visit & Analysis: The vast majority of the district will not have a view of the proposed line due to screening from urban tree cover and residences in the foreground. There is a view of the Lyles substation from the intersection of Darlington St. and Riverview Ct. However, the complexity of the infrastructure within and around the substation will render any transmission reconstruction unnoticeable to casual viewers.

Conclusion Based on the Visual Impact Assessment and Field Visit: Views toward the line are probable but will not be evident to casual viewers due to the complexity of existing electrical infrastructure between the line route and viewpoints.
